Subject: Filter Pump Seal Kit Part Number 17476 - Temporary Deviation

Models Affected: Multiple Fryers and Service Parts

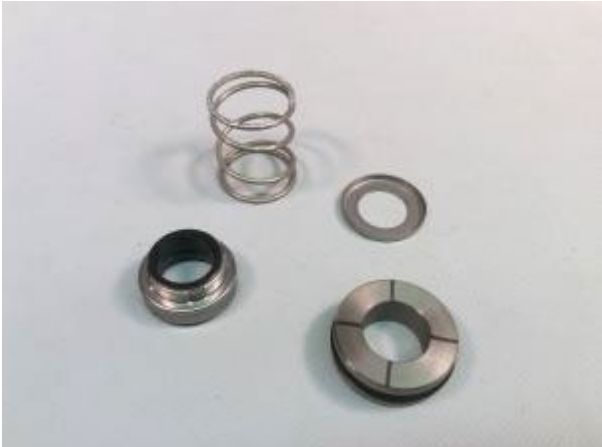
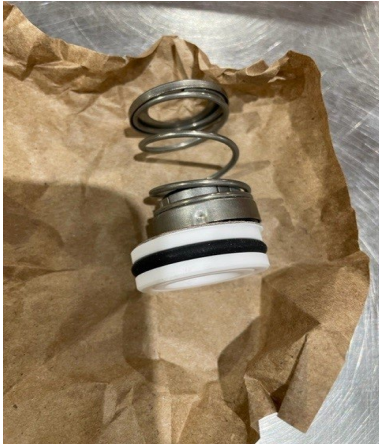
IMPORTANT: Servicers may notice the mating ring is a different material and color. See examples below.

Original Material	Ceramic Material
Machined cast iron bar stock.	Use care when installing as the ceramic is less resistant to impact.

The normal specification for the mating ring included in seal kit P/N 17476 to be made from a machined cast iron bar stock. The temporary mating ring deviation will allow for a ceramic or other suitable alternate materials.

Continue to order seal kit P/N 17476 as usual for service parts. Mating ring material will automatically change to the normal specification when available.
